Notification No.: 20140801

Description: iVIZION® Motor Gear Assembly

Hardware: Motor Gear Assembly

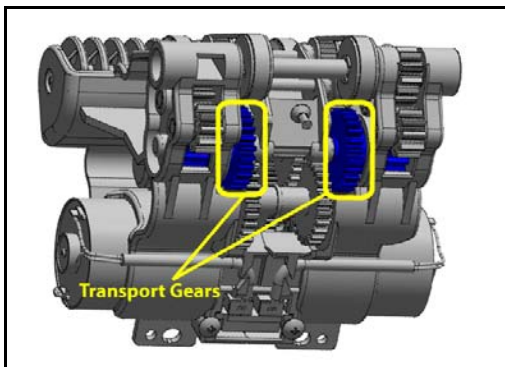
Figure 1: iVIZION Unit Motor Gear Assembly

An investigation by JCM Engineering determined excessive wear on the iVIZION Motor Assembly Transport Gears (Figure 1) may cause inconsistent drive belt movement after 250,000 to 300,000 cycles. JCM Engineering has modified the Transport Gear design as shown in Figure 2 for improved performance, and recommends replacement of these gears if the above conditions are identified. Refer to Section 4 of the iVIZION® Series Operation and Maintenance Manual (JCM Part Number 960-100929R) for Disassembly/Reassembly Instructions for the Motor Gear Assembly. Note: As a courtesy to our customers, JCM has modified its standard production to include this new gear beginning with Production Serial No. 1406208375.

The iVIZION Motor Gear Assembly (EDP #197877) should be maintained as specified in the JCM iVIZION Banknote Validator Preventive Maintenance Instructions (JCM Part No. 960-100932R_Rev. A), available at <http://www.jcmglobal.com/en/support/downloads/manuals.aspx>.
